INVESTIGATION OF PCBs
IN
DOMESTIC SUBMERSIBLE
WATER WELL PUMPS

JUNE 1987

Ontario Ministry of the Environment
Water Resources Branch
Drinking Water Section
June 1987

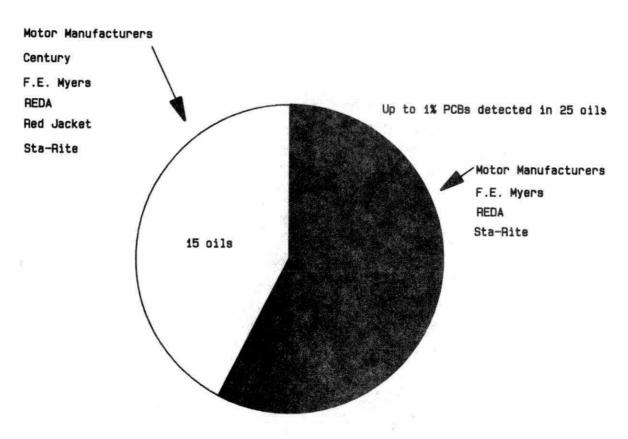
PCBs FOUND IN OILS FROM 25 OF 40 DISCARDED PUMP MOTORS

Results for 3 of 4 sets of replicates analyzed at separate laboratories were comparable. PCB levels in the fourth set were reported as 95 ppm, 74.5 ppm and <1.0 ppm. There is no explanation for this discrepancy.

Total Number Of Motors Oils Examined = 40
